Debris/Ice/TPS Assessment And Integrated Photographic Analysis For Shuttle Mission STS-47

November 1992

DEBRIS/ICE/TPS ASSESSMENT
AND
PHOTOGRAPHIC ANALYSIS
OF
SHUTTLE MISSION STS-47

September 12, 1992

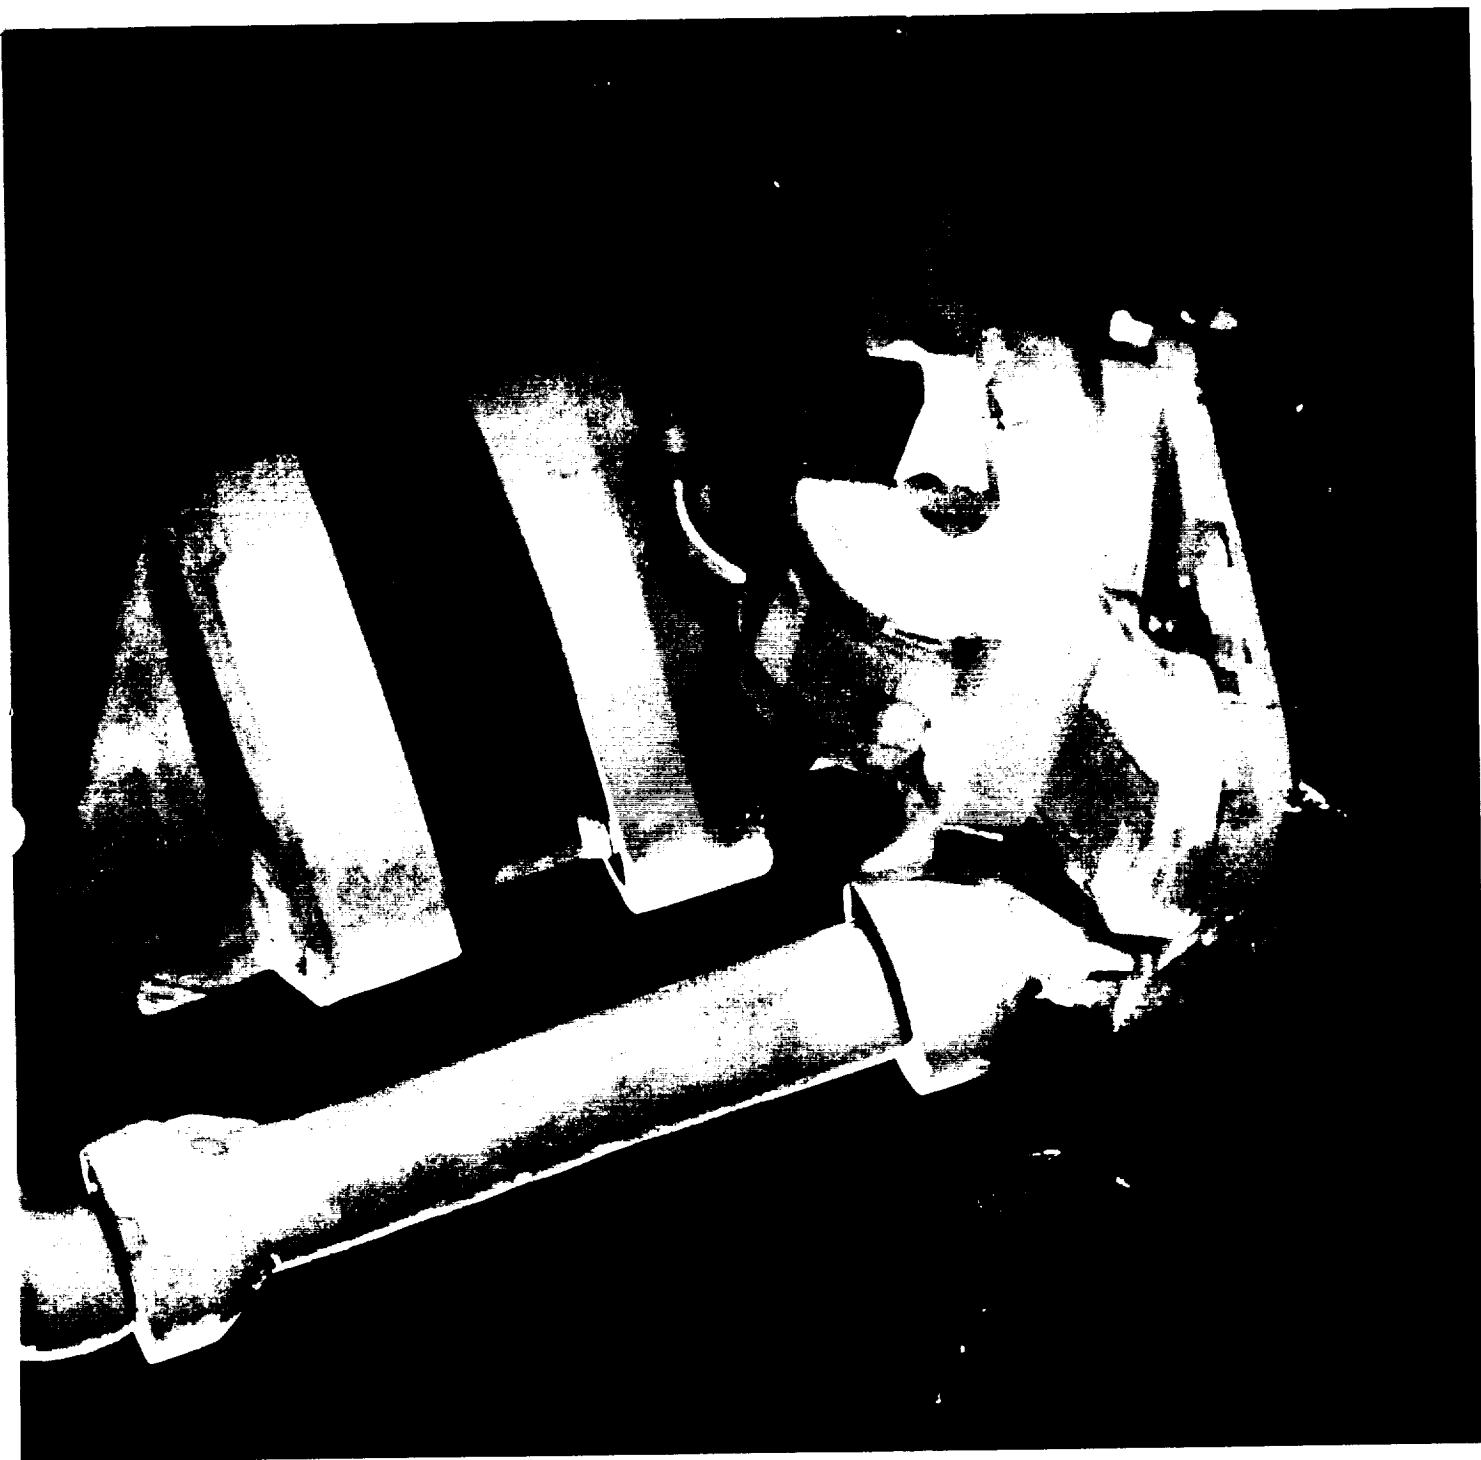
Less than usual ice/frost had formed on the outboard and top sides of the LH2 ET/ORB umbilical/purge barrier. Typical amounts of ice had accumulated on the plate gap and pyrotechnic canister purge vents, and in the LH2 recirculation line bellows

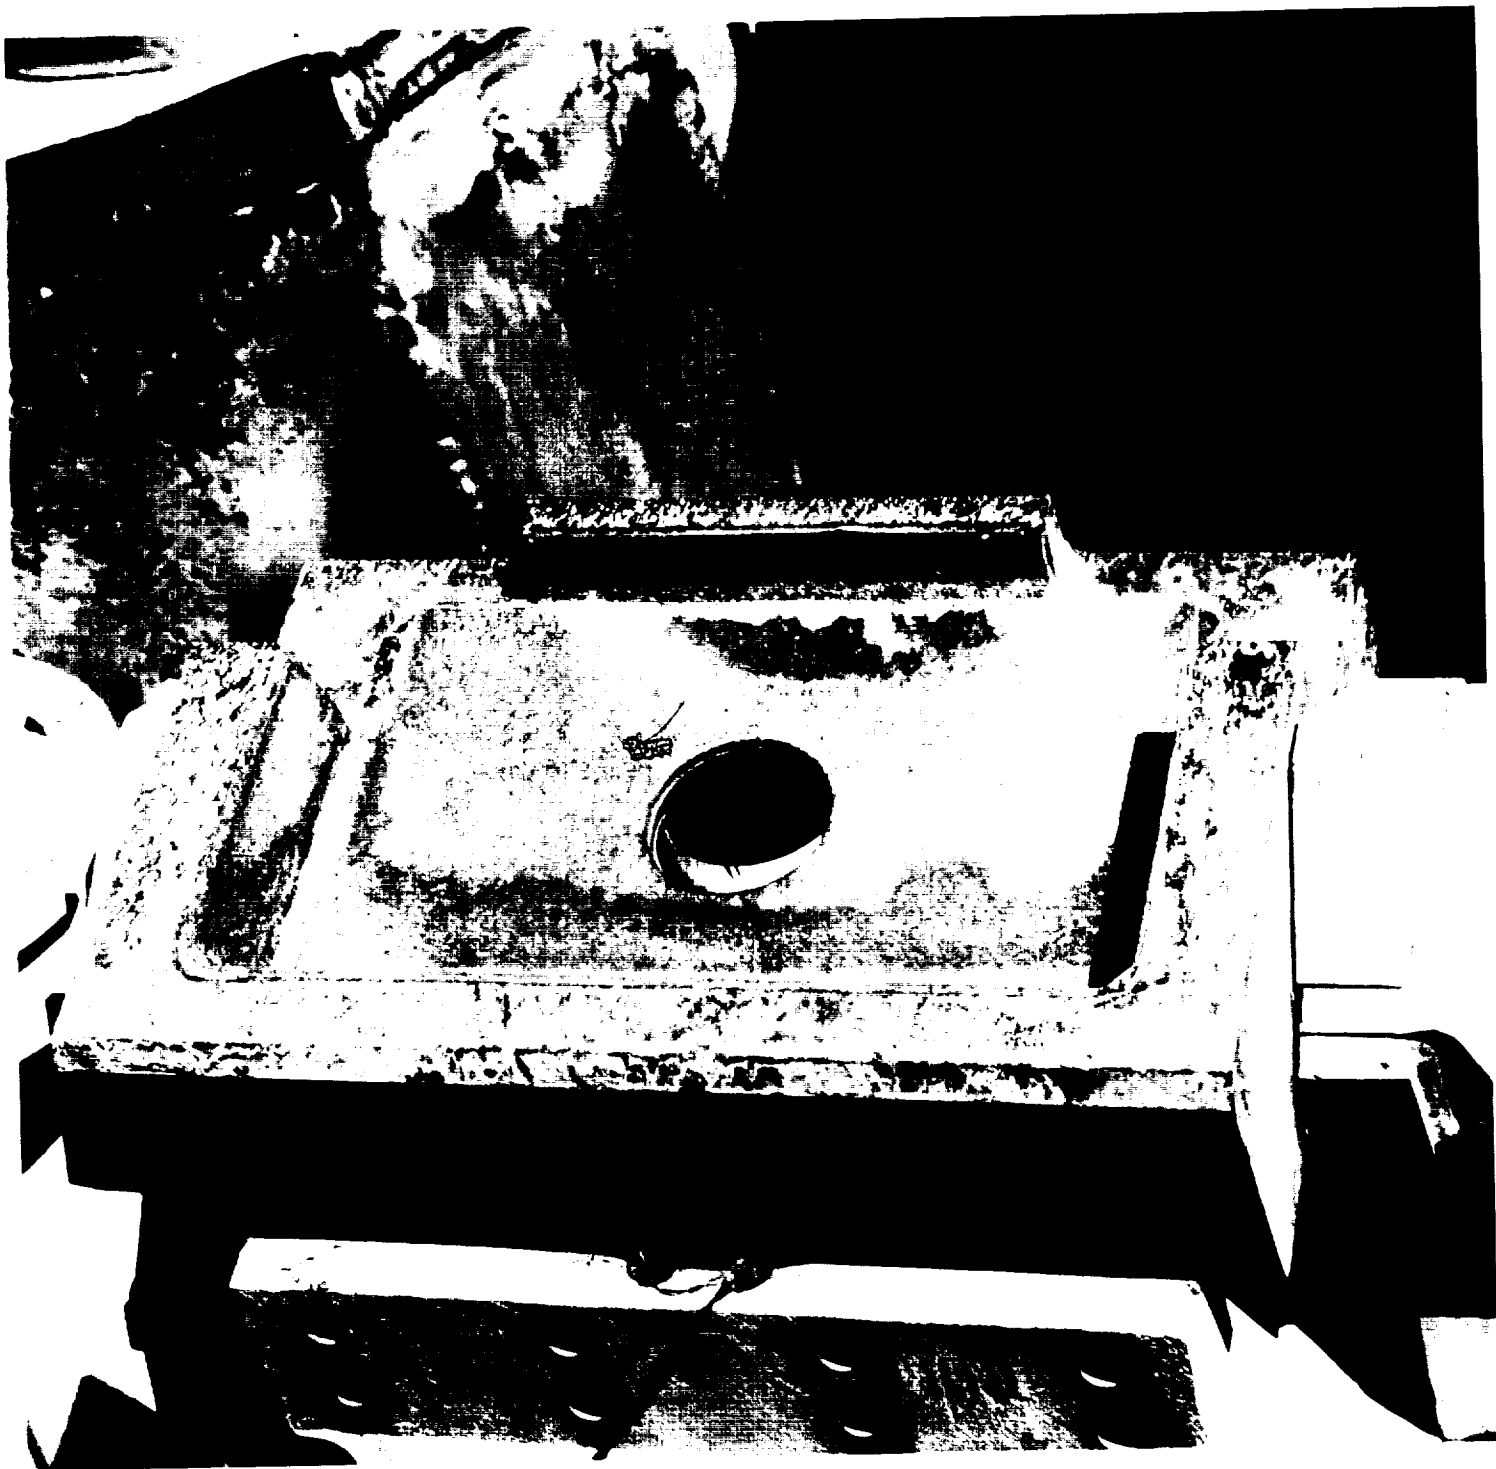
Plume erosion of the south SRB holddown posts was typical. EPON shim material was intact and bonded to the holddown post shoes.

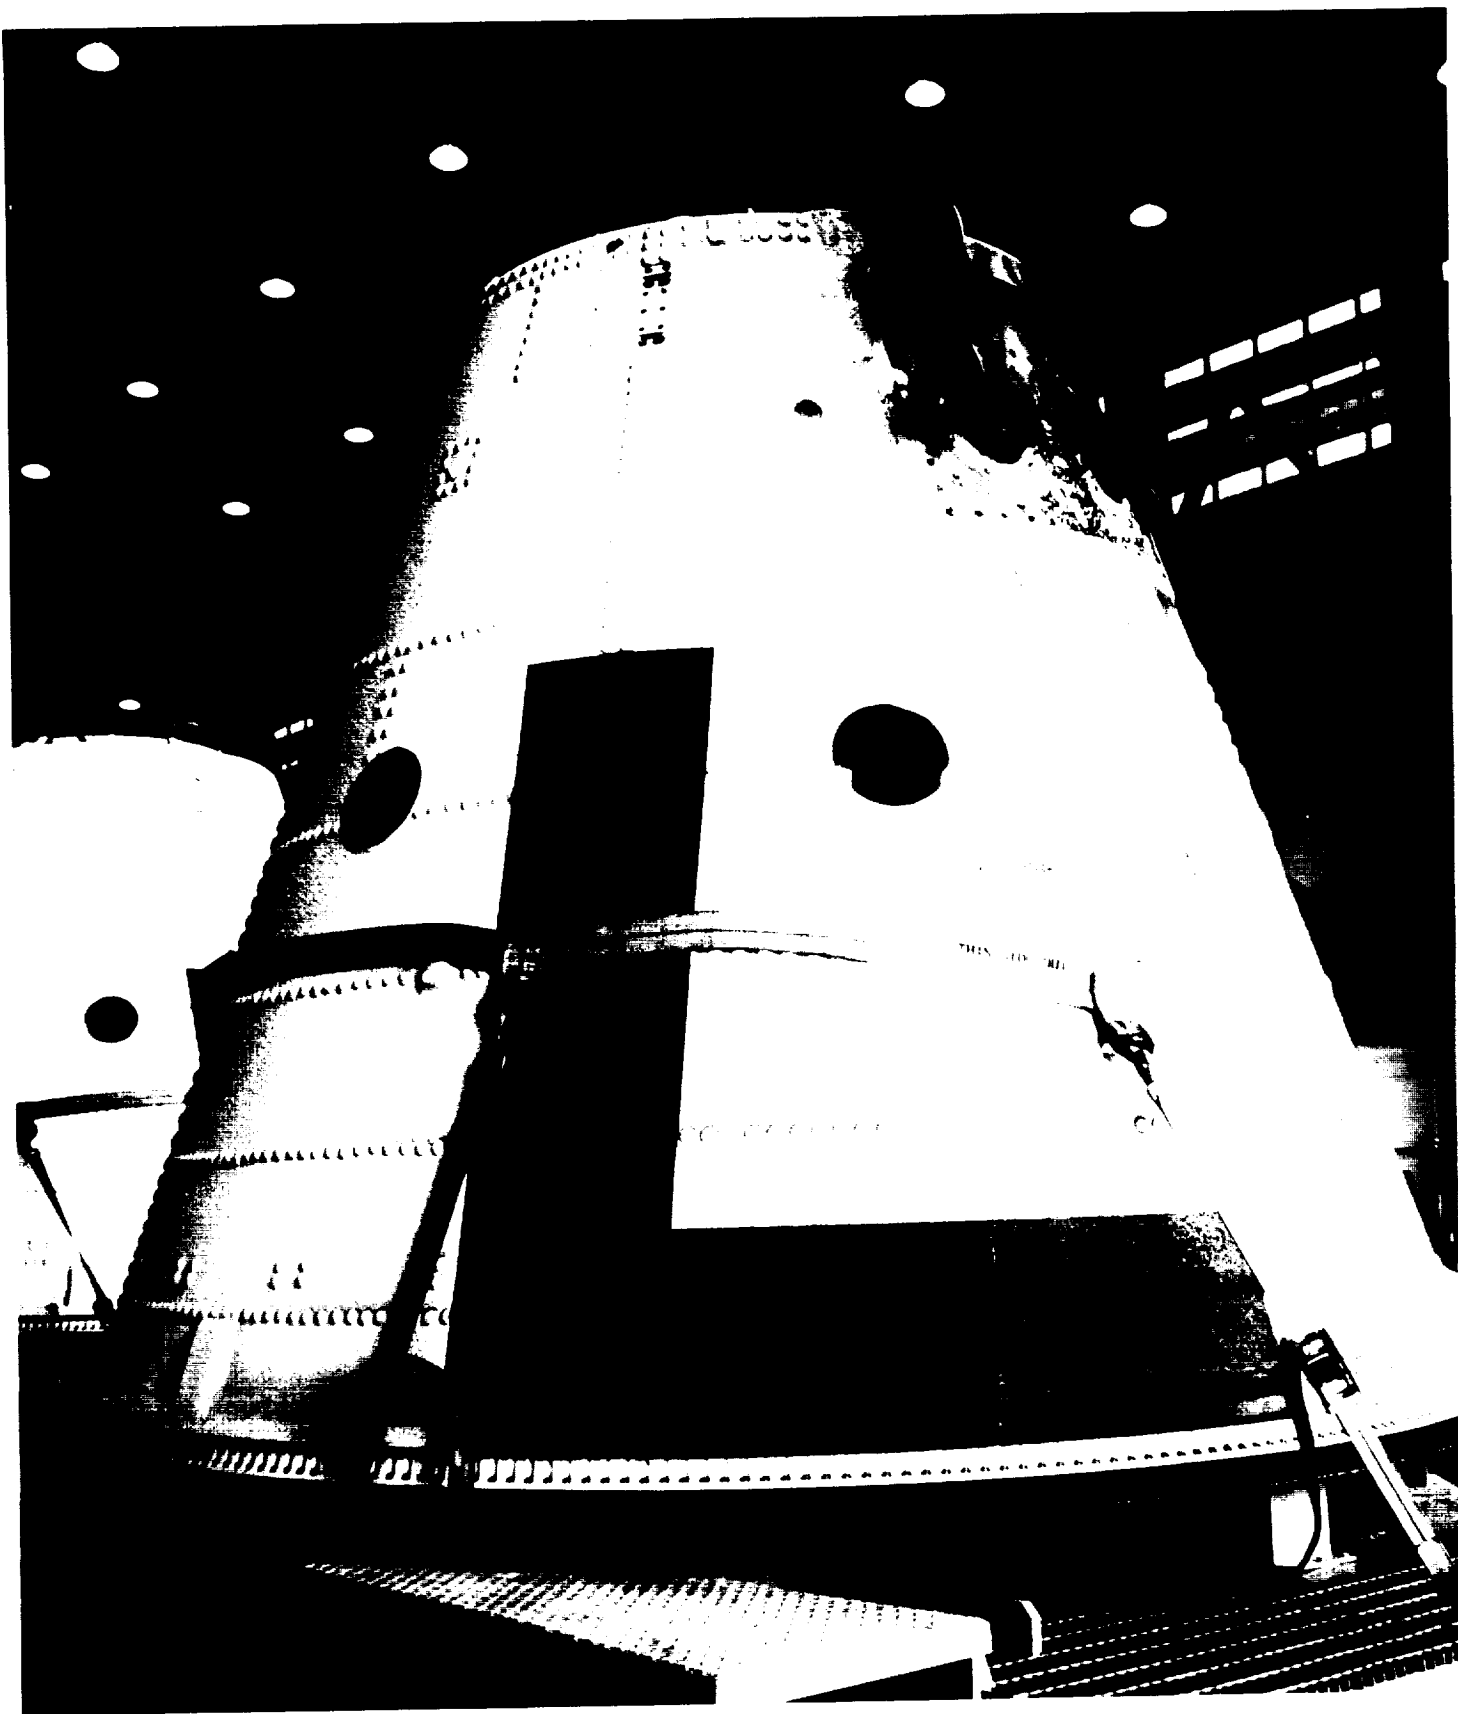
The RH frustum had 42 MSA-2 debonds over fasteners and one area of missing TPS at the -Y axis near the 275 ring frame. All BSM aero heat shield covers were locked in the fully opened position though the left two cover attach rings had been bent by parachute riser entanglement.

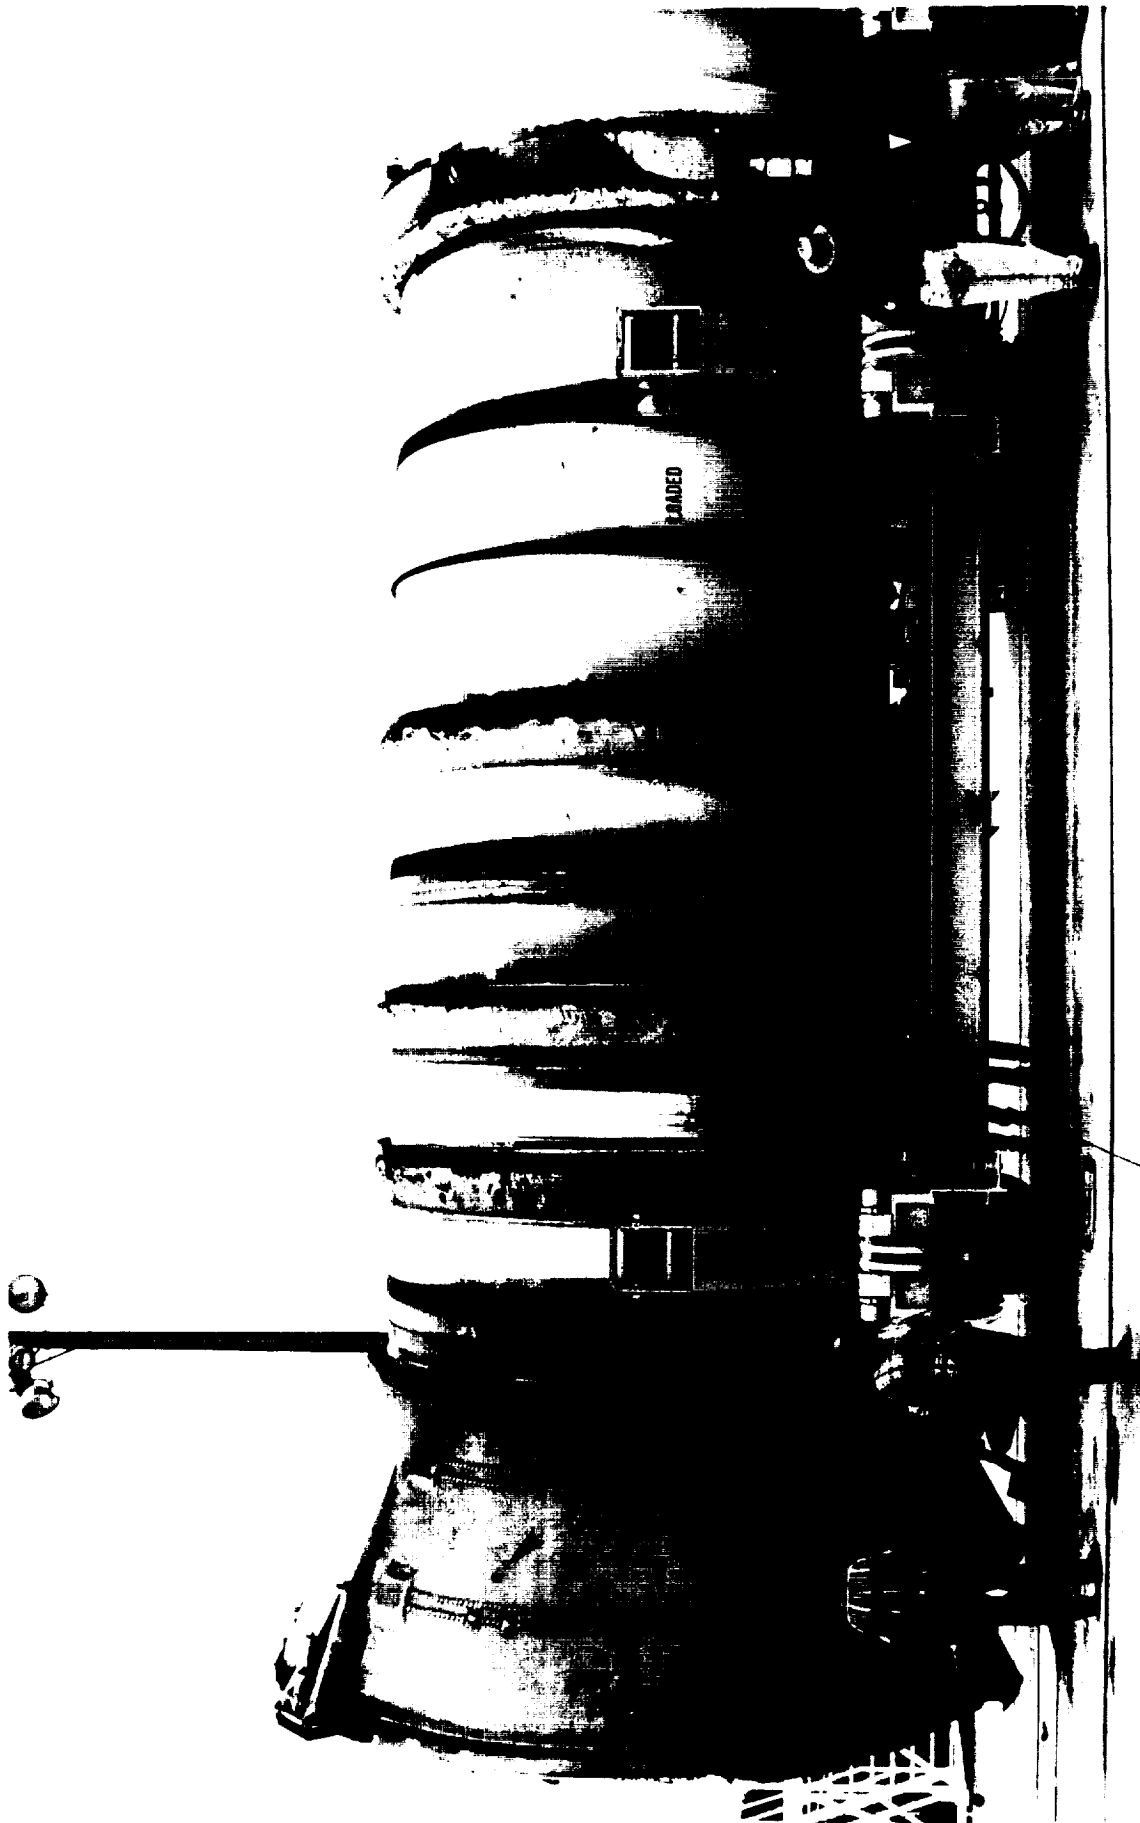
Post flight condition of the RH aft booster. MSA-2 TPS was missing from three areas on the aft skirt acreage. The ET/SRB aft struts, ETA ring, and IEA appeared undamaged. All three aft booster stiffener rings sustained water impact damage.

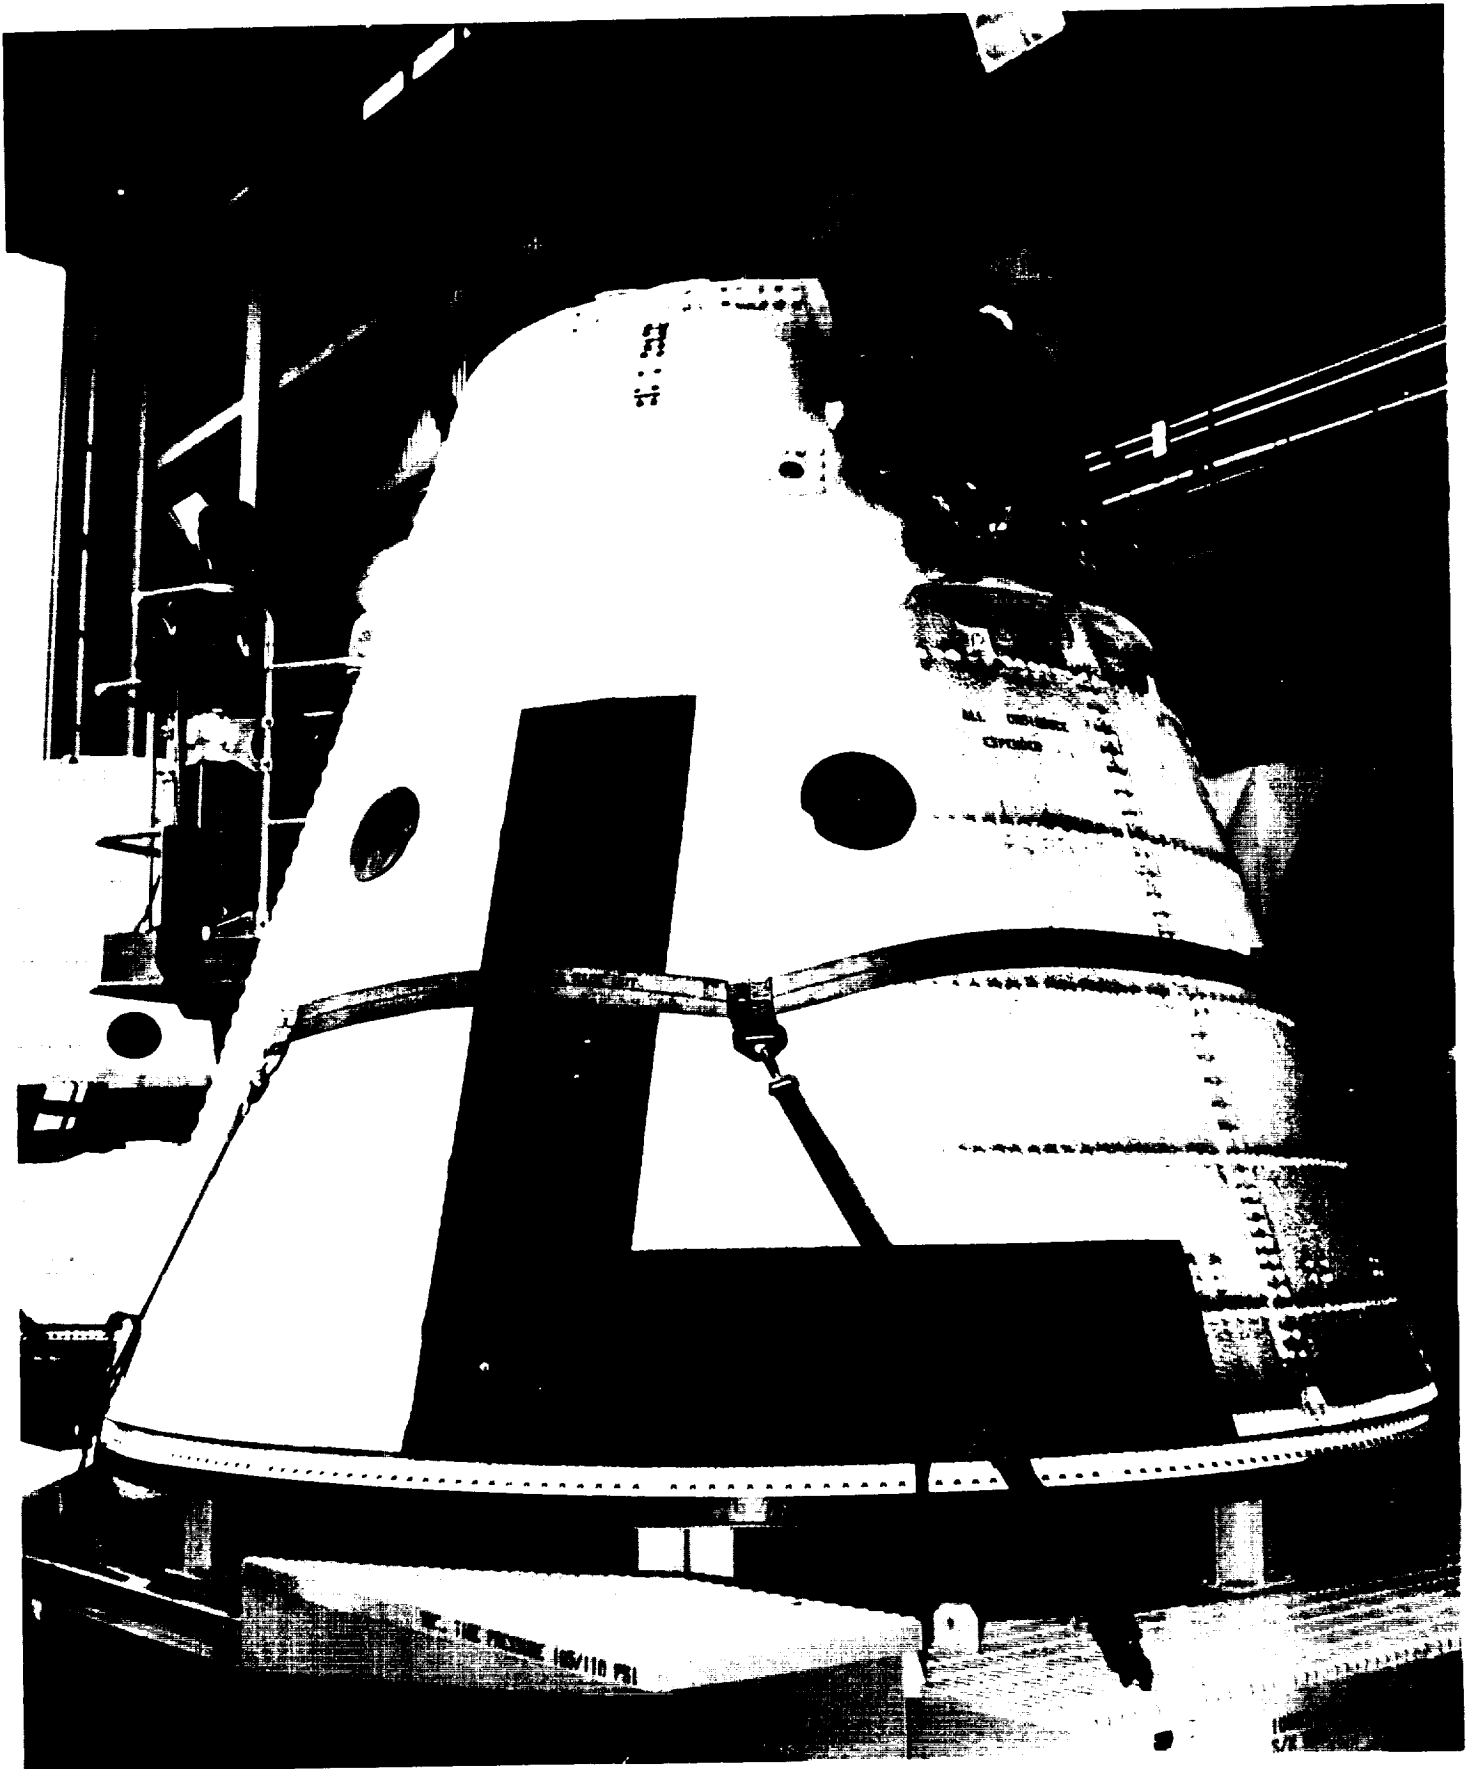
The LH frustum had 25 MSA-2 debonds over fasteners and was missing MSA-2 from one location between the +Y and +Z axes on the 381 ring frame. The BSM aero heat shield covers were locked in the fully opened position.

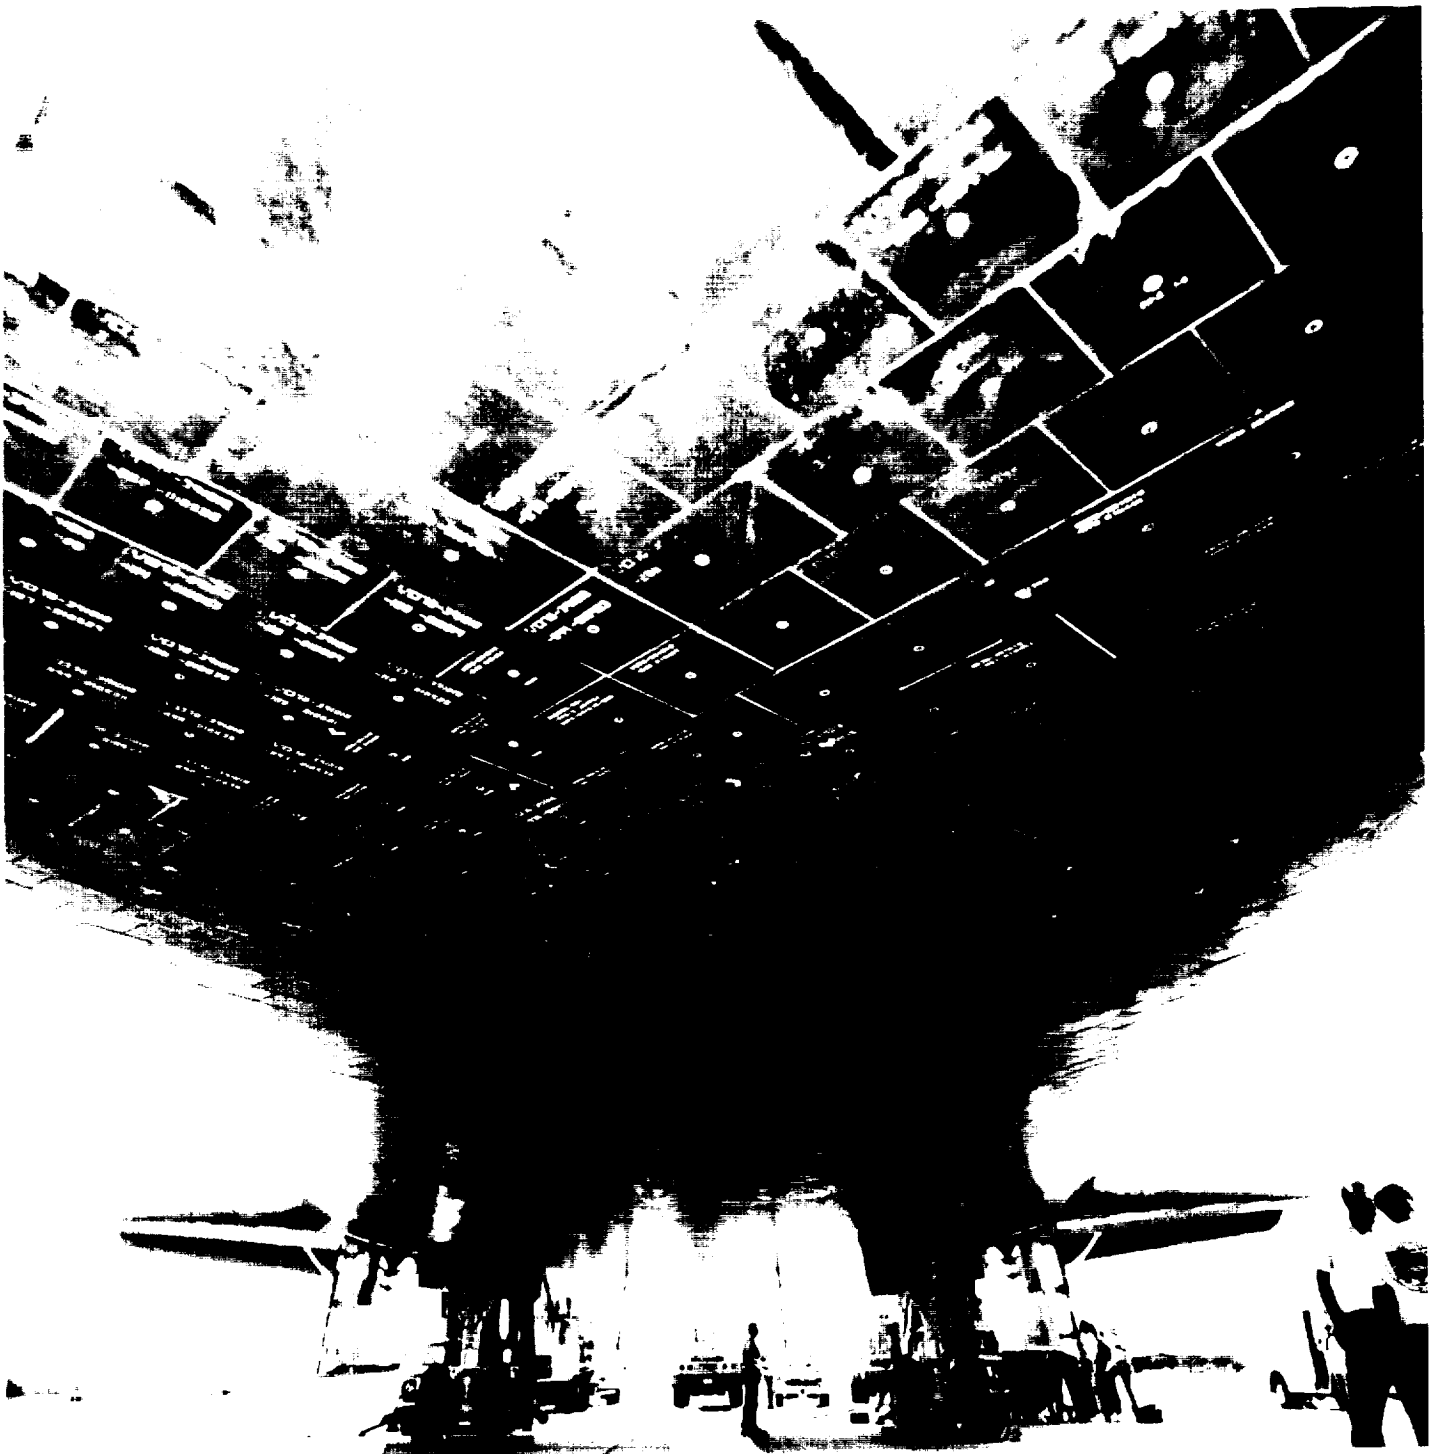
The Orbiter lower surface tiles sustained a total of 47 hits, of which three had a major dimension of 1-inch or greater. These numbers are much less than average.

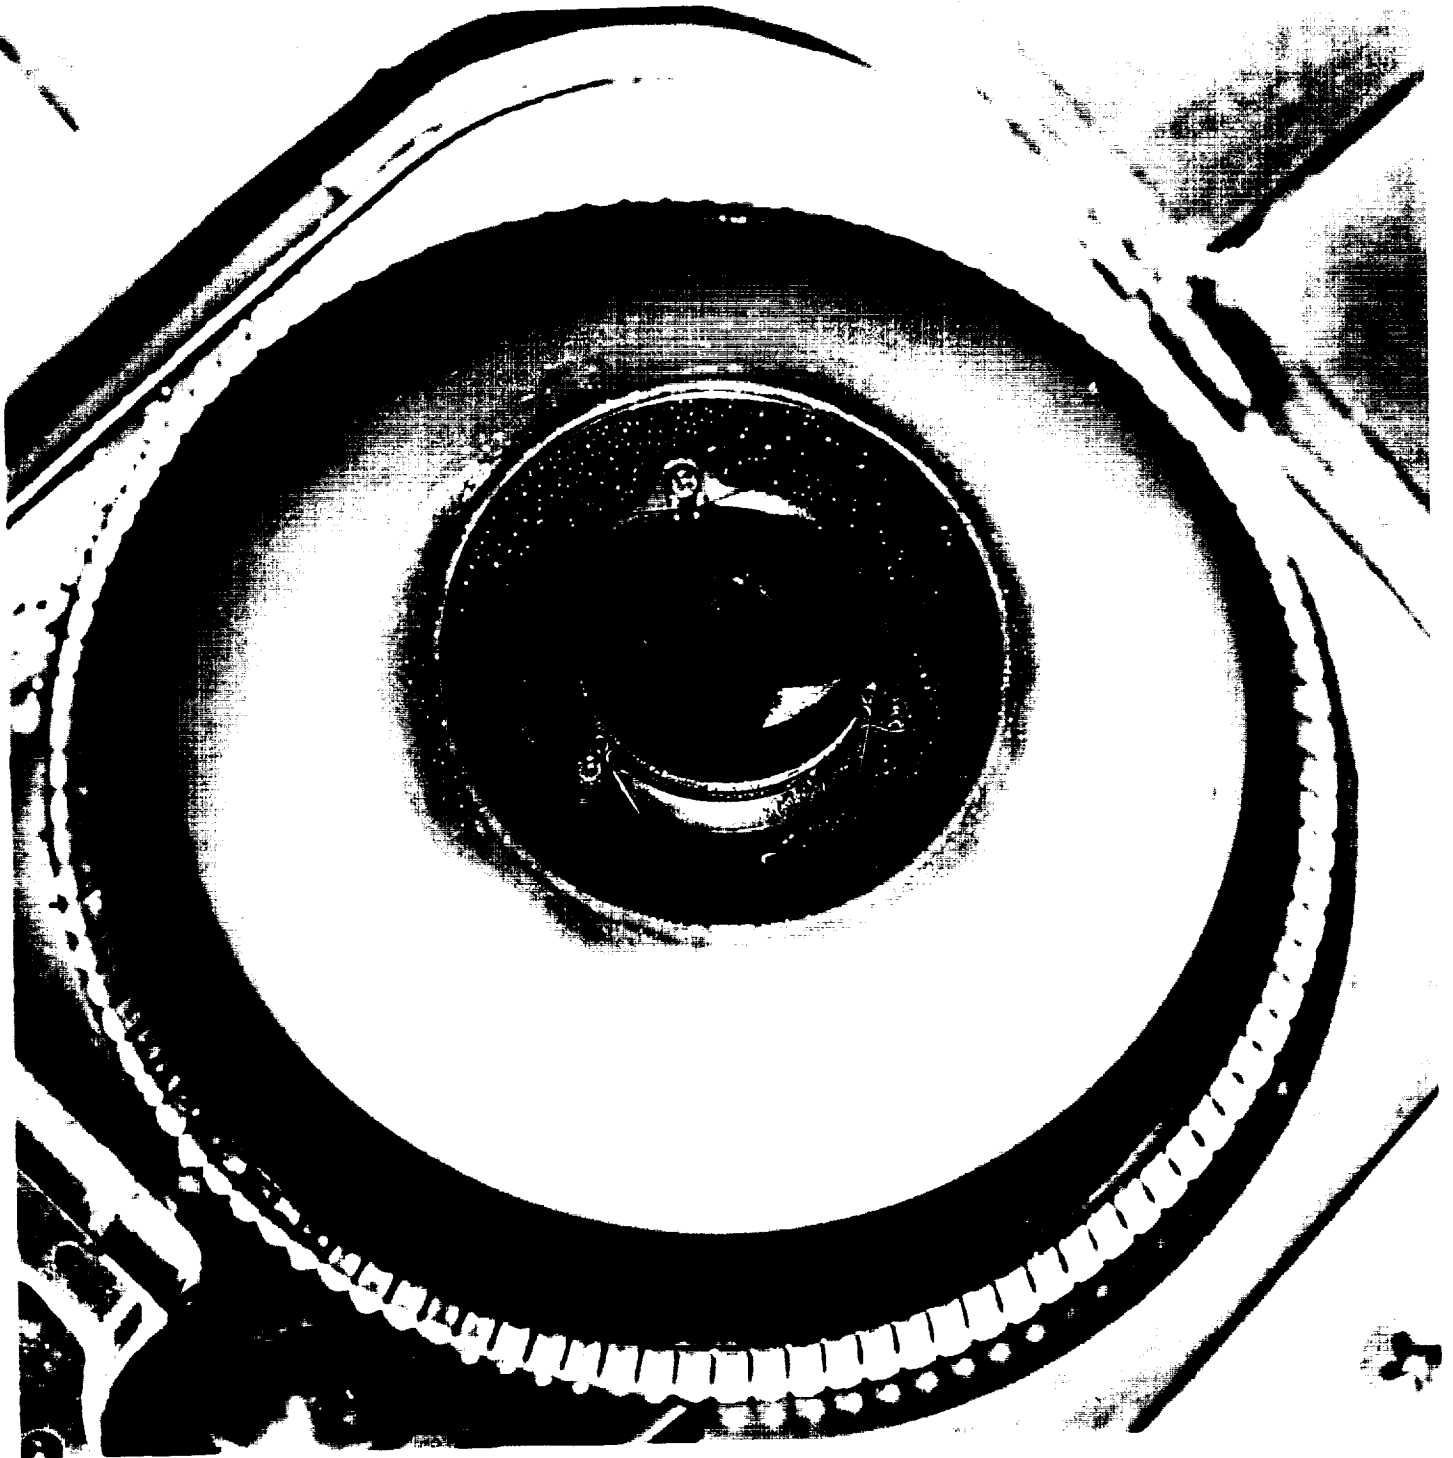
The EO-3 (LO2) separation device debris plunger was obstructed by two ordnance fragments and was prevented from seating
